Historic Bridge Rehabilitation Analysis Phase 1 SR 1002 (Skinners Falls Road) over Delaware River

BMS# 63-1002-0230-0739

AECOM

May 2023

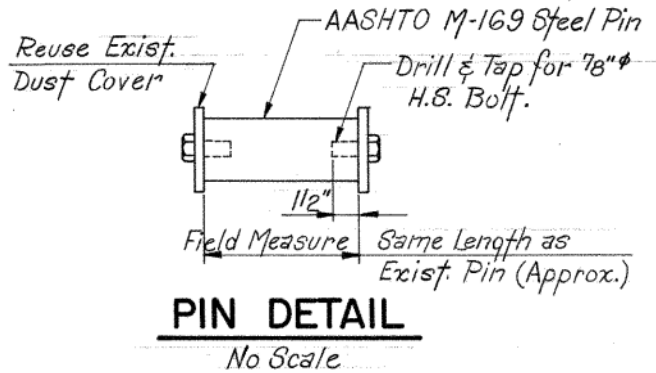
Figure 8: Existing Pin Detail, 1986 Rehabilitation Drawings

The original pins, as illustrated in the 1986 rehabilitation plans (**Figure 8**), consisted of a single diameter steel pin, with two dust caps, which were secured to the pin with bolts. The dust caps (**Figure 9**) are the only portions of the pin that are visible on the bridge. The existing pins do not have “shoulders” as per current code, which would minimize the sliding effects of the current pins. In their current deteriorated condition, the pins are also susceptible to sliding due to bridge movements. For these reasons, pin replacement and cleaning of connections is a base recommendation for this and all other rehabilitation options. The proposed replacement shouldered pins (**Figure 10**) are anticipated to consist of a steel pin to match the same length of the existing pin. The replacement pins are anticipated to include a machined shoulder on one side, which will match the existing dust cover diameter. On the opposite side of the pin from the steel shoulder, a threaded end will be present. The combination of a shouldered nut (**Figure 10**) and the machined shoulder will minimize sliding effects. The shouldered nut will be slightly larger than the existing dust cap in order to provide retention of the bridge members and would be visible on the bridge. The proposed pin replacements will not change the overall function of the bridge as a pin-connected through truss, will replace a deteriorated bridge member, and add an added layer of protection to prevent sliding of bridge members. Therefore the pin replacements would be performed in-kind, result in a more stable preservation of the bridge, and reduce the potential of catastrophic failure due to bridge members sliding off the pins.

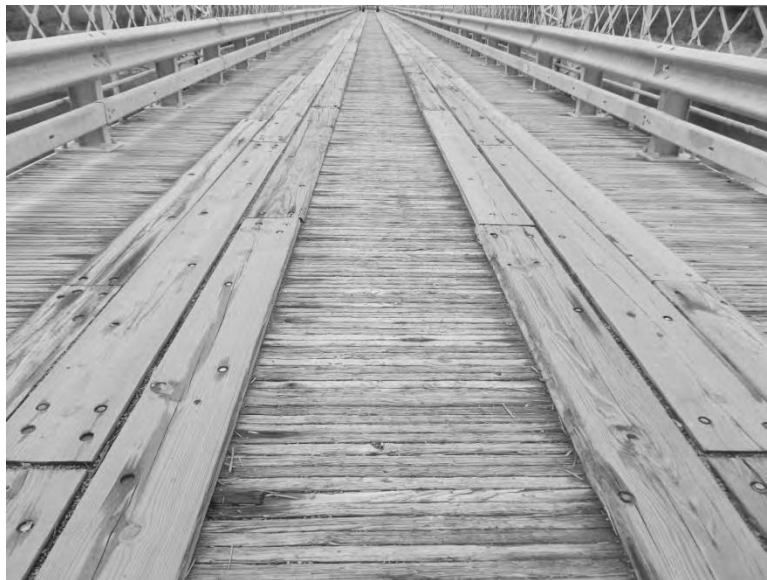
- Missing longitudinal running boards and rot of the transverse timber deck (Photos 4, 5, 33-35)
- Longitudinal running boards with missing or protruding fasteners (Photo 35)
- Underside of the timber deck exhibits checks, splits, seepage stains and localized areas of rot and active seepage throughout (Photo 19)

Photo 4 - Skinnners Falls Bridge: Typical Top of Deck and Bridge Rail

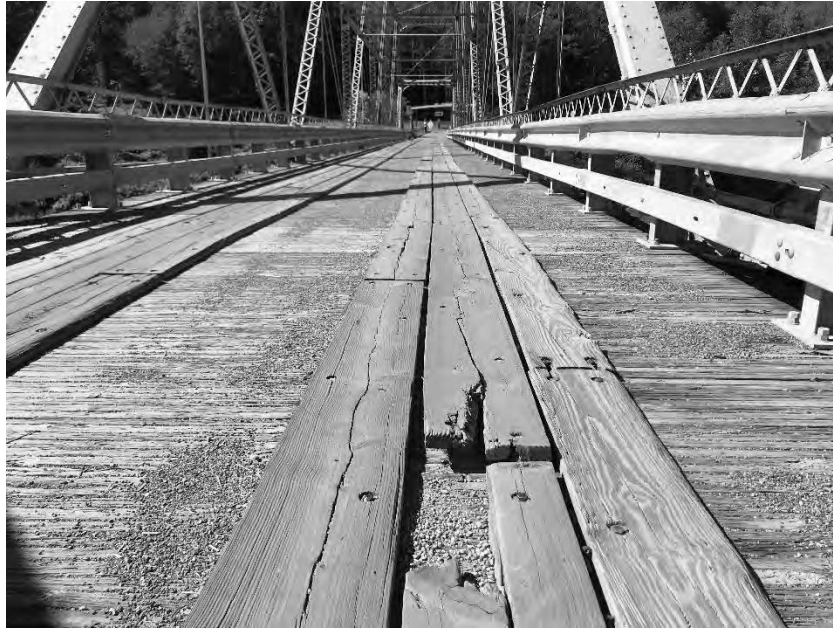
Photo 5 - Skinners Falls Bridge: Timber Running Board Deterioration

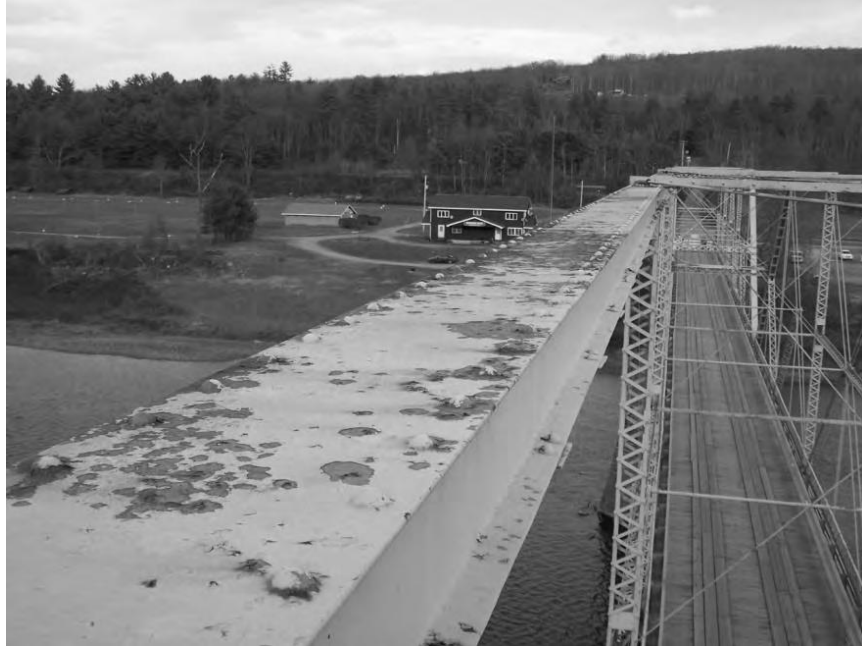
Photo 9 - Skinners Falls Bridge: Left Truss Top Chord flaking paint and minor surface rust

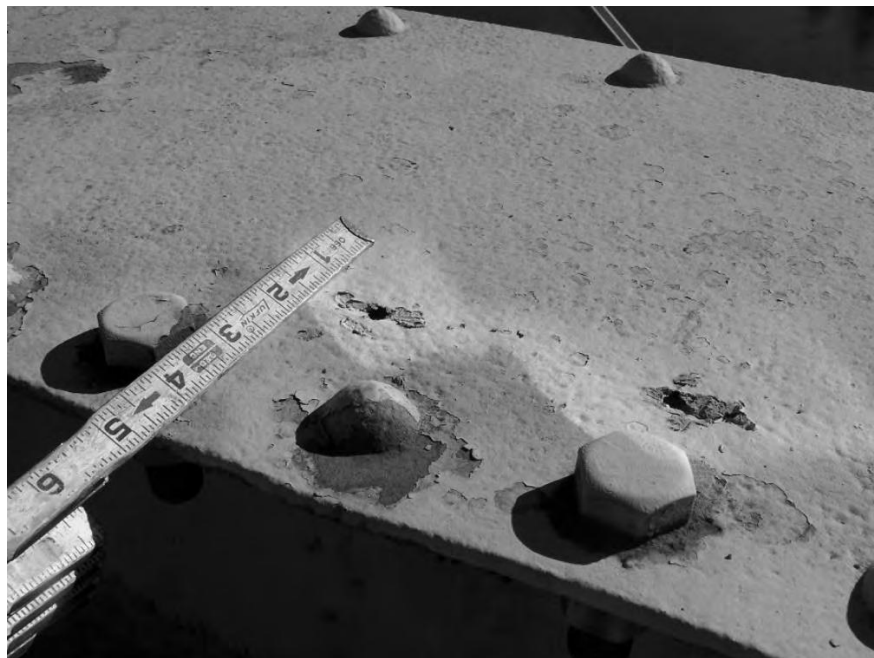
- Top chord members exhibit localized areas of severe rust with up to 100% section loss in Span 1 (Photo 10)
- Bent and misaligned bolts in top chord splices in Span 2 resulting in displacement of top chord channels (Photo 11)

Photo 10 - Skinners Falls Bridge: Left Truss Top Chord section loss

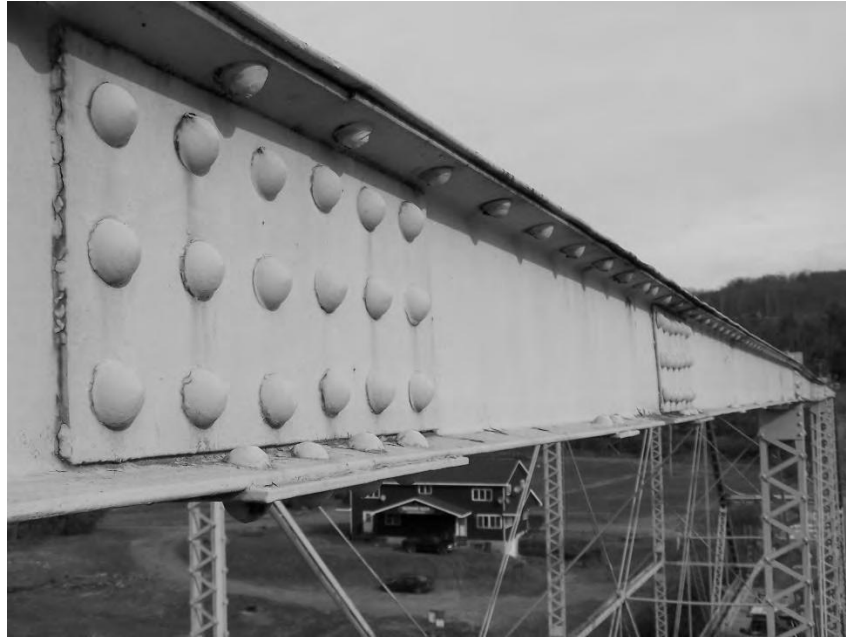
Photo 11 - Skidders Falls Bridge: Bent and misaligned bolts in top chord splices in Span 2 resulting in displacement of top chord channels.

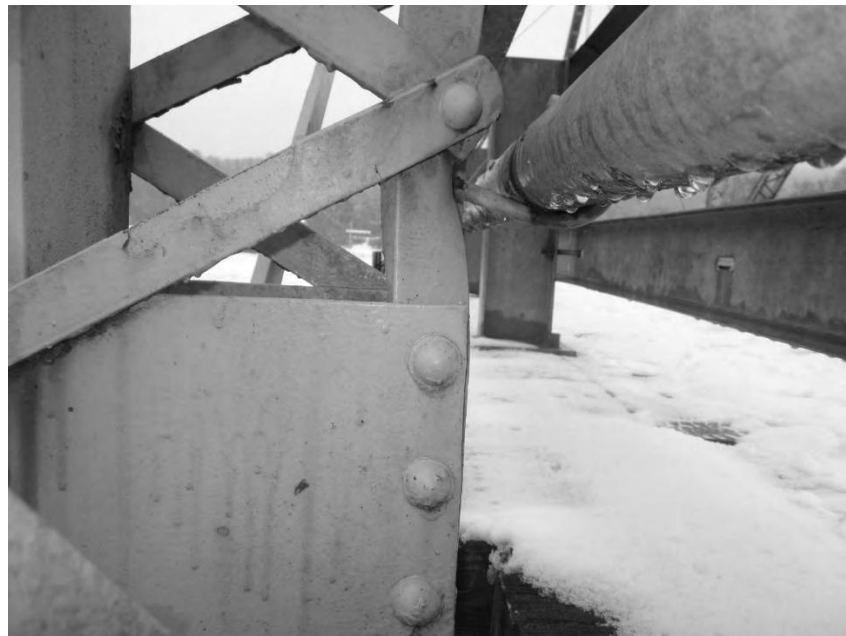
- Collision damage to vertical and end post members at deck level and tension diagonals behind the bridge railing (Photo 12)
- End post channels exhibit localized areas of 100% section loss at pin plates (Photo 15)

- Pack rust and section loss of pinned connections at top, middle, and bottom joints (Photos 17, 18)
- Advanced section loss at pins and forged eyebar heads with up to 50% section loss noted for several members throughout structure (Photos 12, 13)

Photo 12 - Skidders Falls Bridge: Collision damage to vertical members at deck level behind the bridge railing

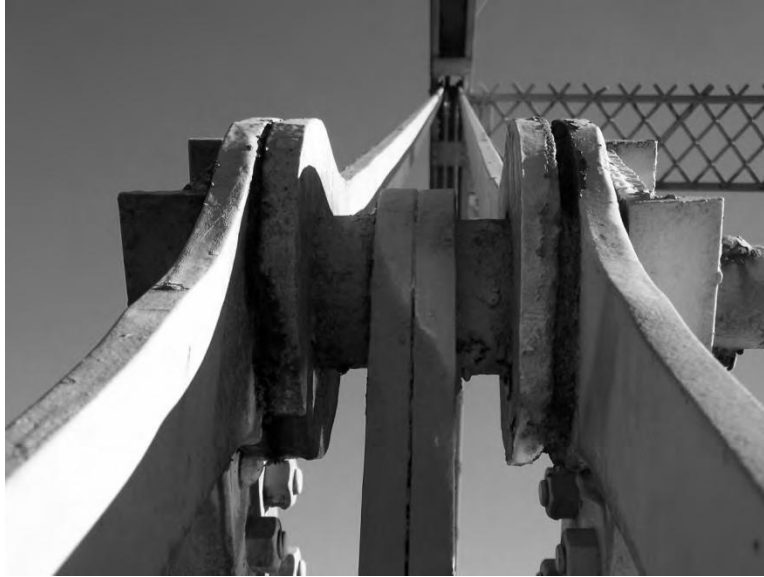
Photo 13 - Skinners Falls Bridge: Typical losses to eyebar heads at middle panel points

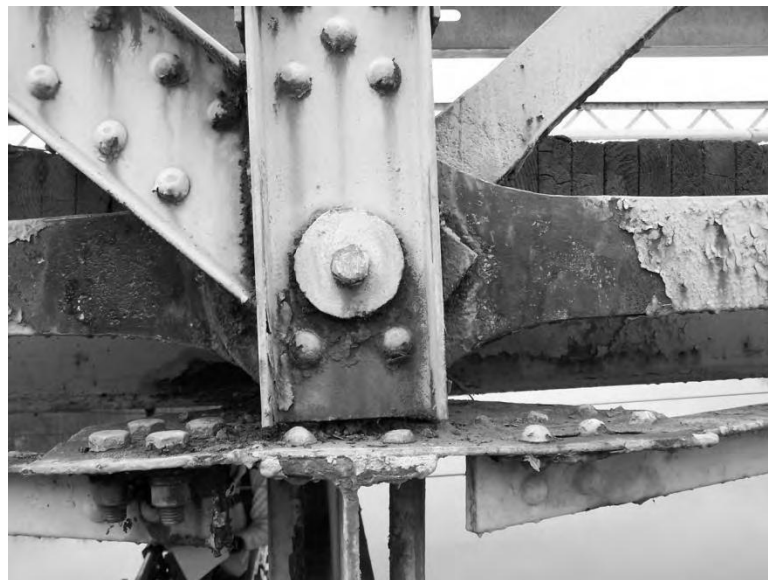
Photo 14- Skinners Falls Bridge: Span 1, Right Truss, Panel Point L8 retrofit pin cap (Looking Left)

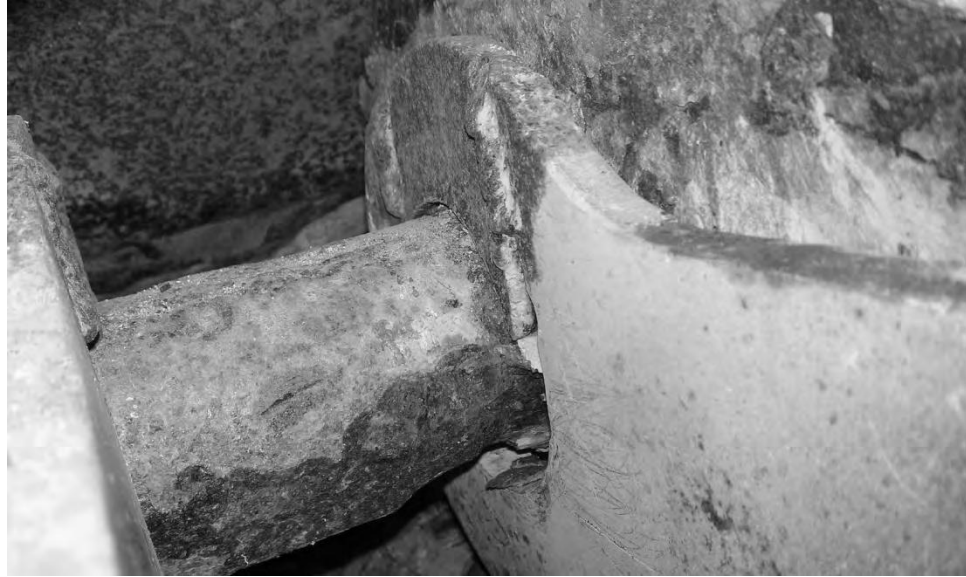
- Existing field welded and bolted repairs to lower chord forged eyebar heads (Photo 15)
- Several tension diagonals and hangers do not appear to be carrying any loads (photo n/a)

Photo 15 - Skinners Falls Bridge: ¼" Section Loss to one side of pin at Span 1, Left Truss, Panel Point L0 (Looking Back)

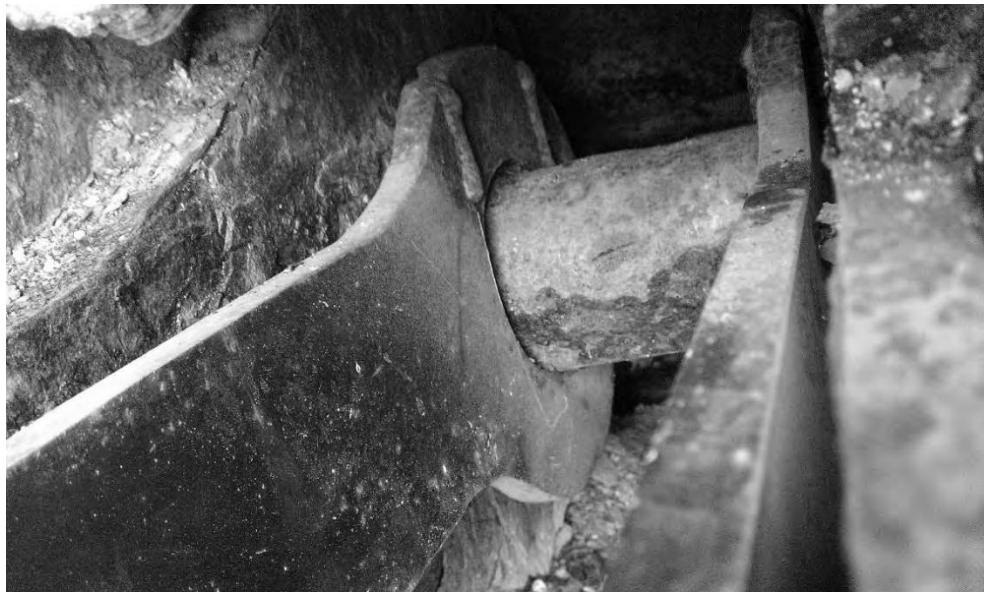
Photo 16 - Skinners Falls Bridge: Existing field welded s to lower chord forged eyebar heads

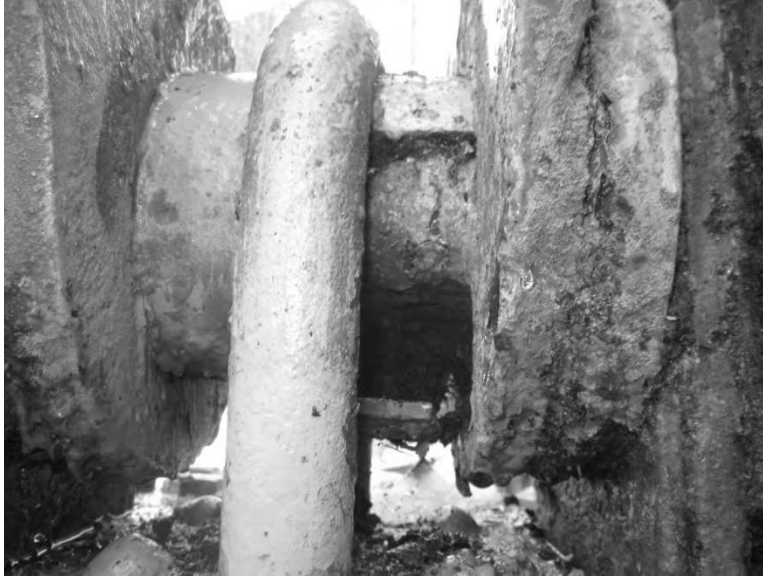
Photo 17 - Skinnners Falls Bridge: Span 1, Left Truss, Panel Point L6 pin sleeve broken (Looking Ahead)

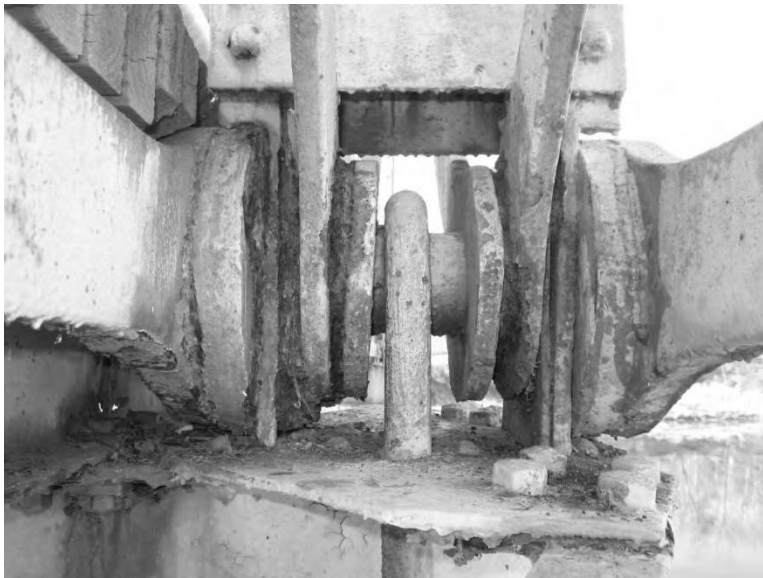
Photo 18- Skinnners Falls Bridge: Span 2, Left Truss, Panel Point L6 extensive pack rust (Looking Back)

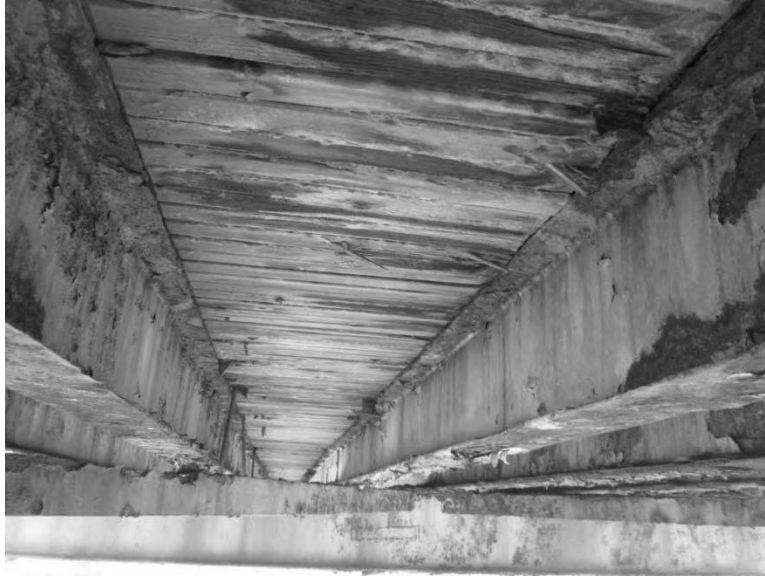
- Missing or deteriorated clips connecting timber to stringer top flange (Photos 19,20)
- Gaps between the stringer top flanges and deck underside (Photo 20)
- Metal plate deck joint audibly deflects under traffic (photo n/a)

- Remaining original stringers exhibit advanced section loss of 50-100% (Photos 19, 20)
- Floorbeams exhibit advanced section loss (Photos 21-22)
- Floorbeam supports have numerous defects or had been previously retrofitted (Photo 21)

Photo 19 - Skinners Falls Bridge: Typical deck underside condition. Note missing clips

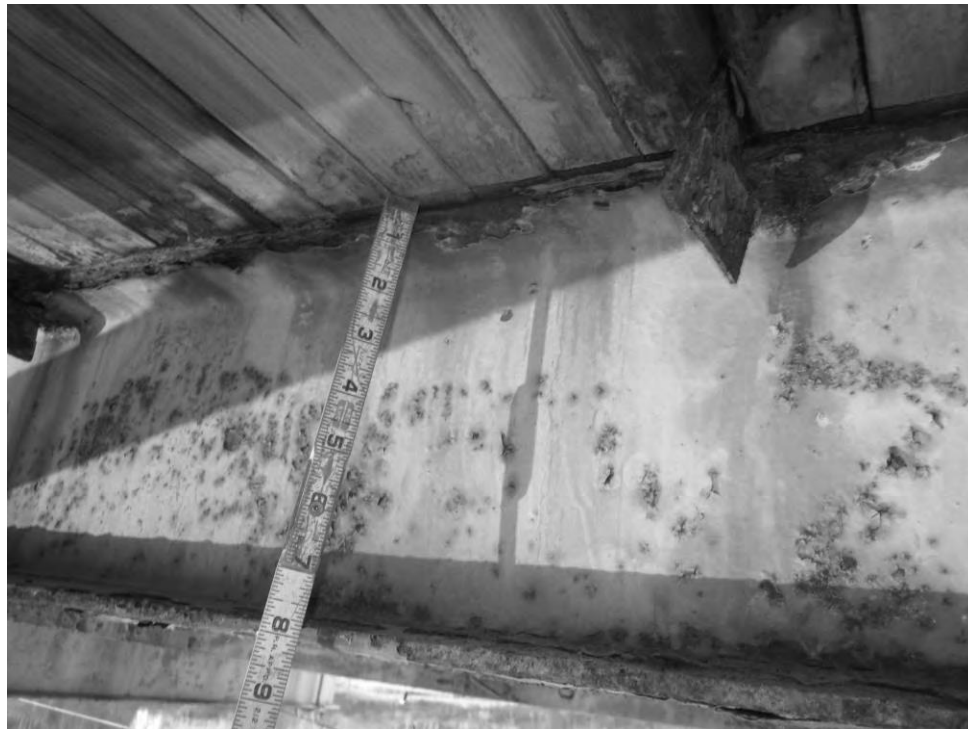
Photo 20 - Skinners Falls Bridge: Gap between stringer and deck due to section loss

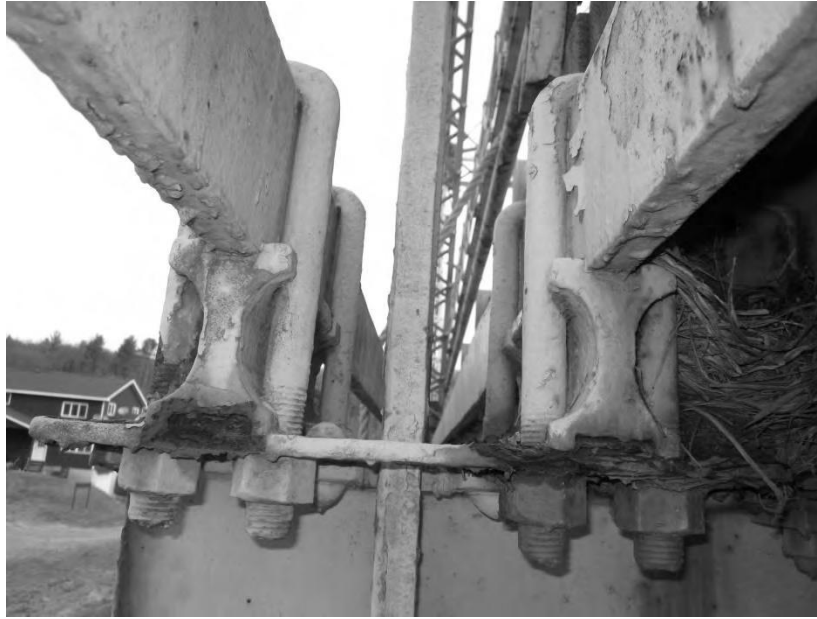
Photo 21 - Skinners Falls Bridge: Floor Beam Support deterioration

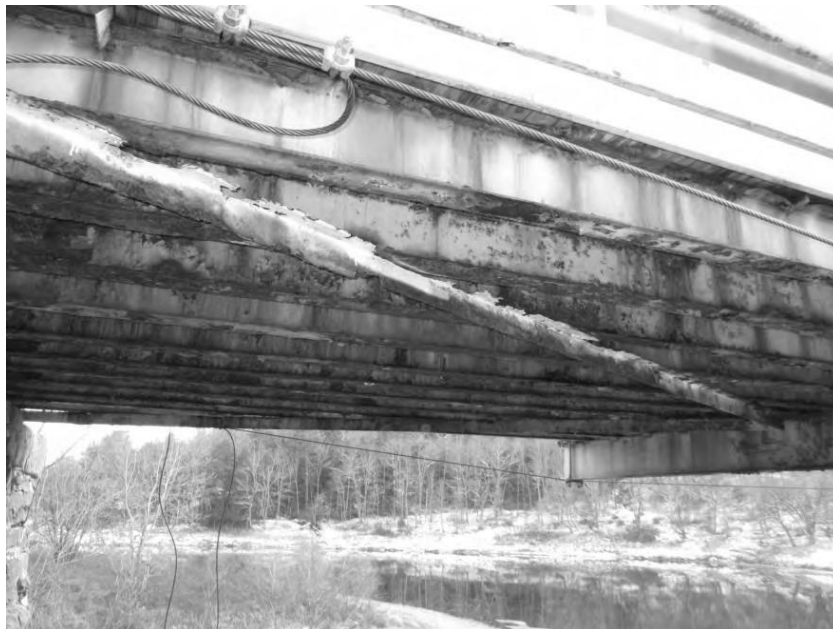
Photo 22 - Skinners Falls Bridge: Span 2, Floor Beam Bay 12, 100% section loss to bottom lateral bracing

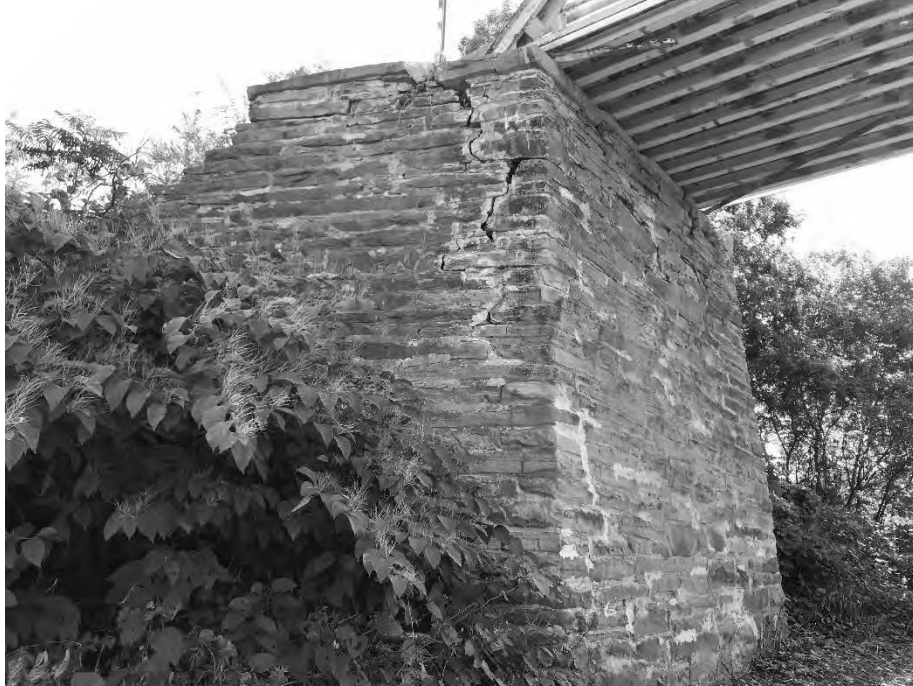
- Abutment bridge seats (cap stones) are cracked or fractured at 3 of 4 locations (Photos 23-26)
- Stone masonry abutment stems with hairline to medium cracks in stones. (Photos 23-25)
- Wide mortar joints with deep voids at the top half of the near abutment (Photos 26)
- Stone masonry wingwalls are displaced with wide cracks following the mortar joints and through stones (Photo 24)
- Far abutment masonry is failing and documented to be in severe condition with wide cracks between adjacent stone masonry units with significant loss of backfill. Cracks are active due to freeze/thaw cycles and are actively monitored every 6 months (Photos 23-25).

Photo 23 - Skinners Falls Bridge: Far Left Wingwall with Crack Monitoring Points and Full Height Step Cracking

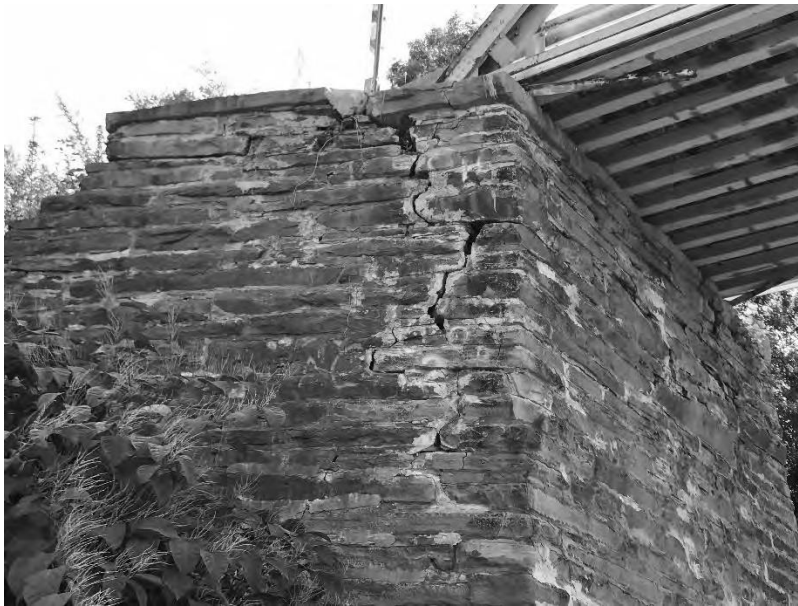
Photo 24 - Skinners Falls Bridge: Far Left Wingwall with Crack Monitoring Points and Full Height Step Cracking

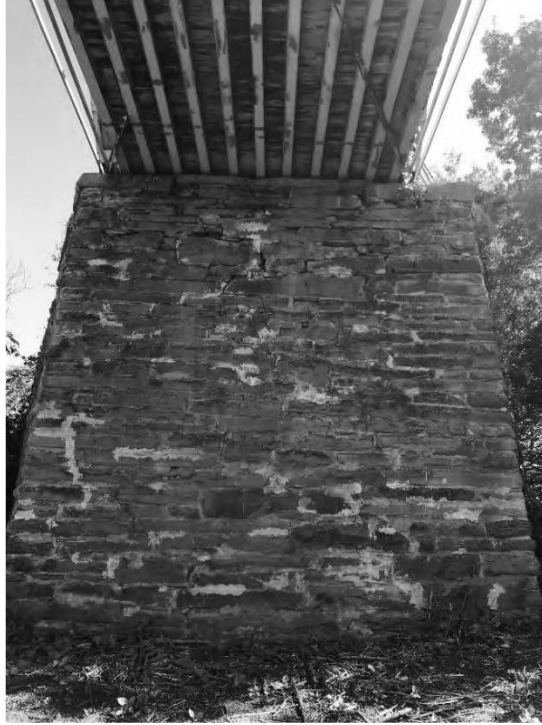
Photo 25 - Skinners Falls Bridge: Far Abutment with Crack Monitoring Points and Full Height Step Cracking

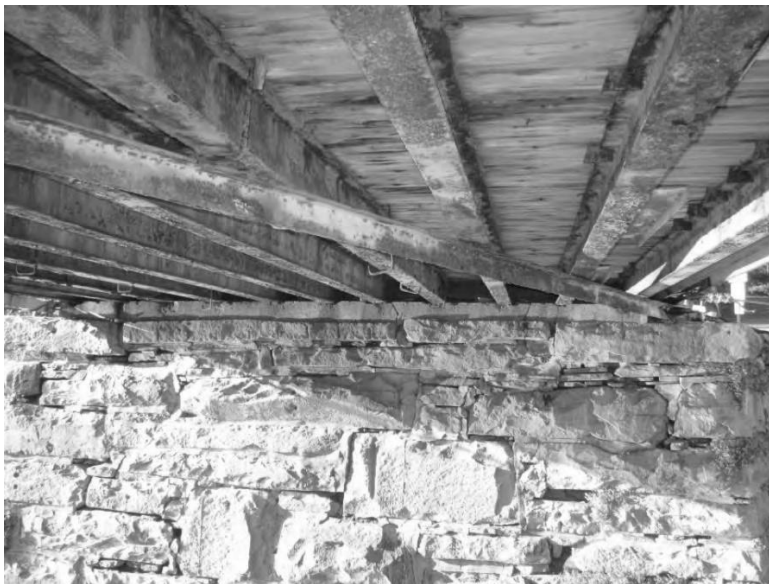
Photo 26 - Skinners Falls Bridge: Near Abutment with wide mortar joints with deep voids at the top half

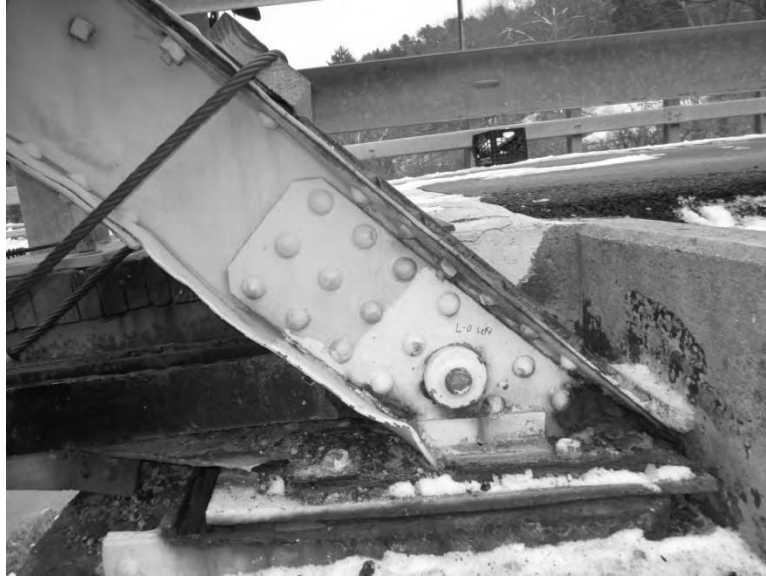
Photo 29 - Skidders Falls Bridge: Near Abutment Left Truss

- Truss bearings at each abutment are frozen and exhibit pack rust (Photo 29)

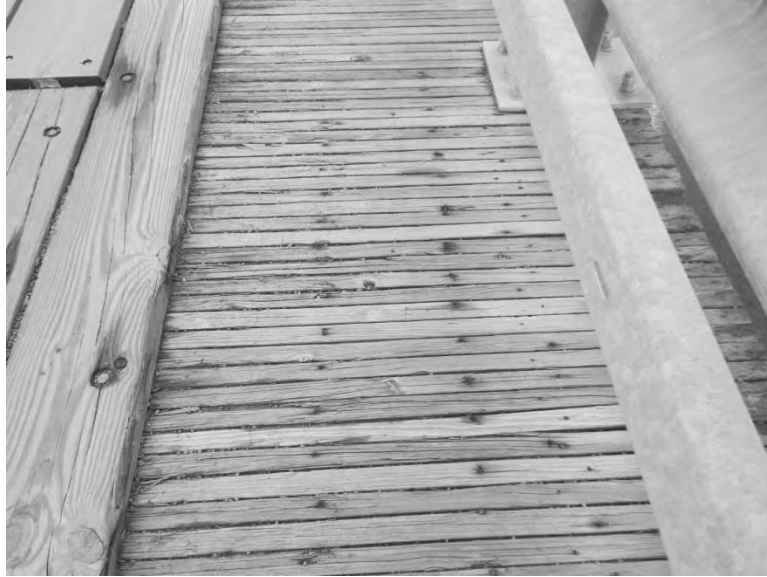
Photo 33 - Skinners Falls Bridge: Typical Deterioration of Left Edge of Deck.

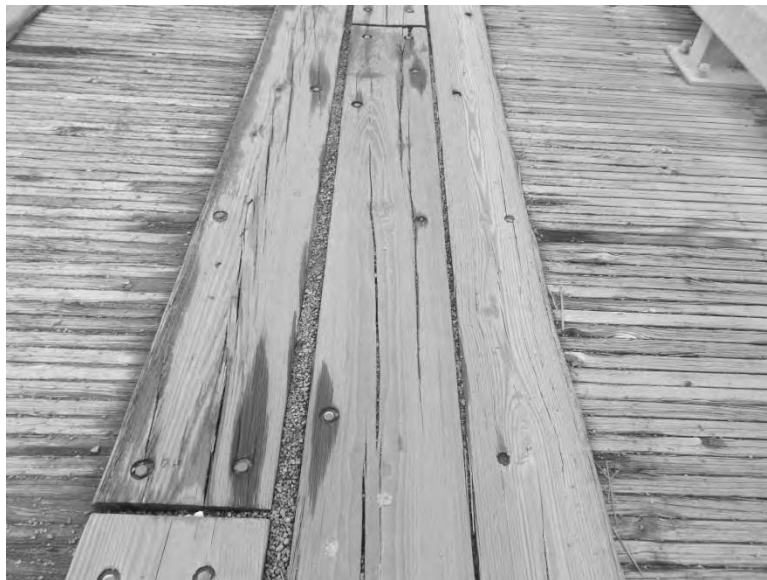
Photo 34 - Skinners Falls Bridge: Typical Cracks and Splitting Throughout Left Tread

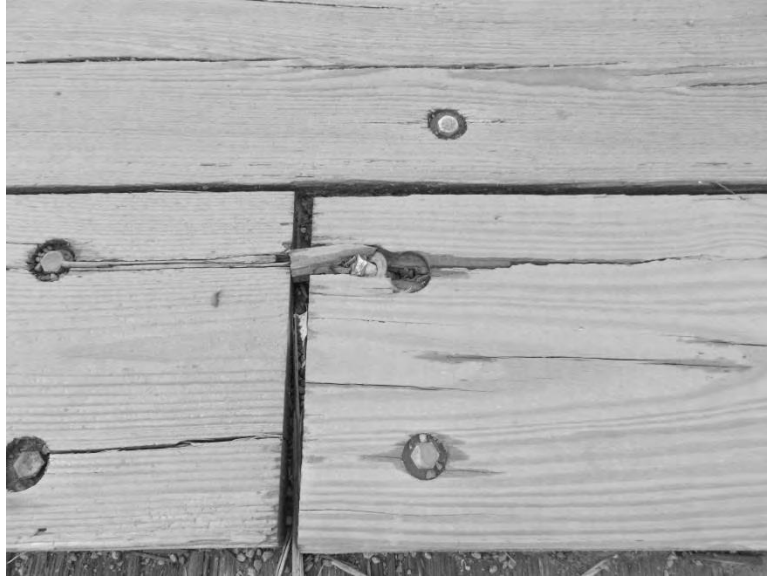
Photo 35 - Skinners Falls Bridge: Typical Damaged Tread Connection (Span 2 Shown)
